Outline of Presentation

1. Introduction
2. Review of Geological Conditions
3. Fundamentals of Drilling and Sampling
4. Findings in Hole 10 (Oct to Dec 1969), Hole G202 (June 1970) and Hole 10X (Oct 1970 to July 1971)
5. Findings in Hole G201 and 201X (June to Dec 1970)
6. TV Images in Bedrock Cavity (Aug 1971)
7. Diving Inspections (Aug 1971 and Aug to Sept 1972)
8. Parkin Sonic Survey in Bedrock Cavity (Oct 1973)
9. Inspection Holes in 10X Casing (Oct 1976)
10. Shaft to Bedrock (1978 to 1990)
- 11. Ice Holes (1979 and 1987) and Dye Tests (1988 and 1995)**
12. Commentary on 10X
13. Acknowledgements
14. References

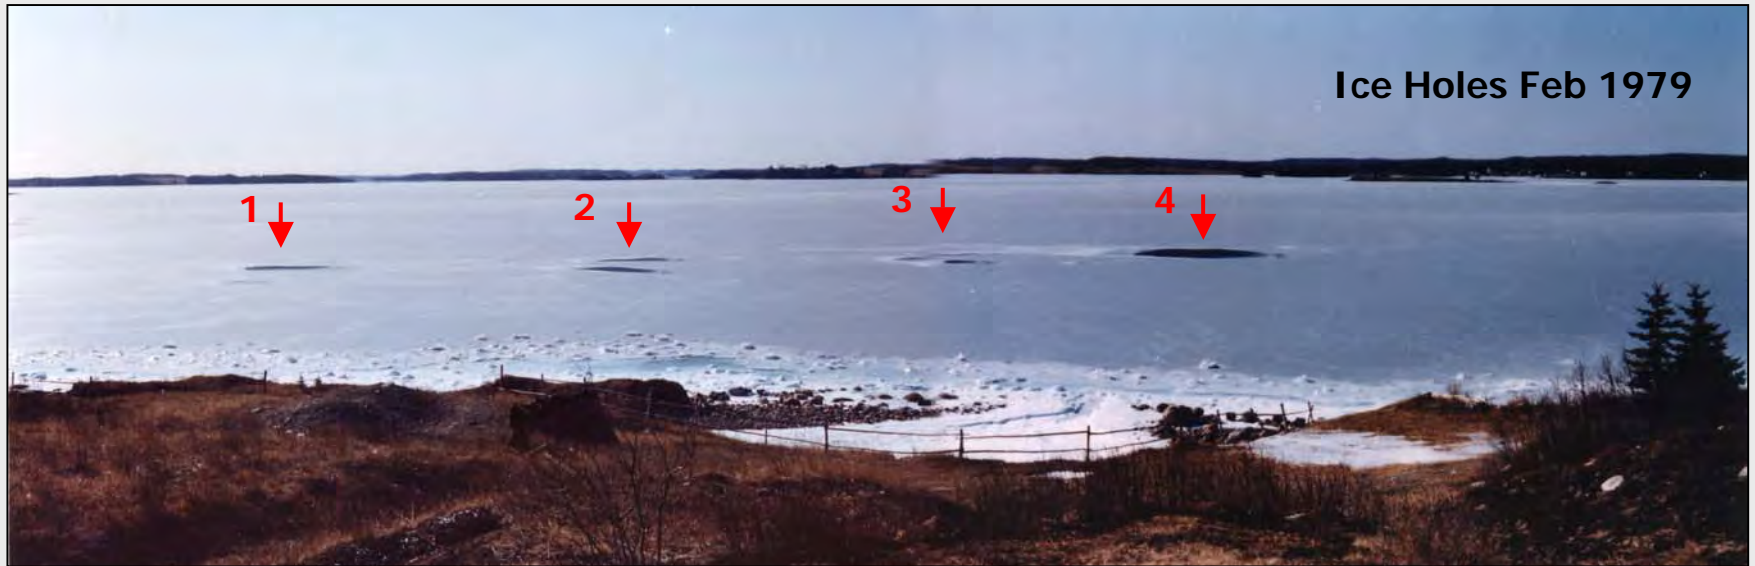
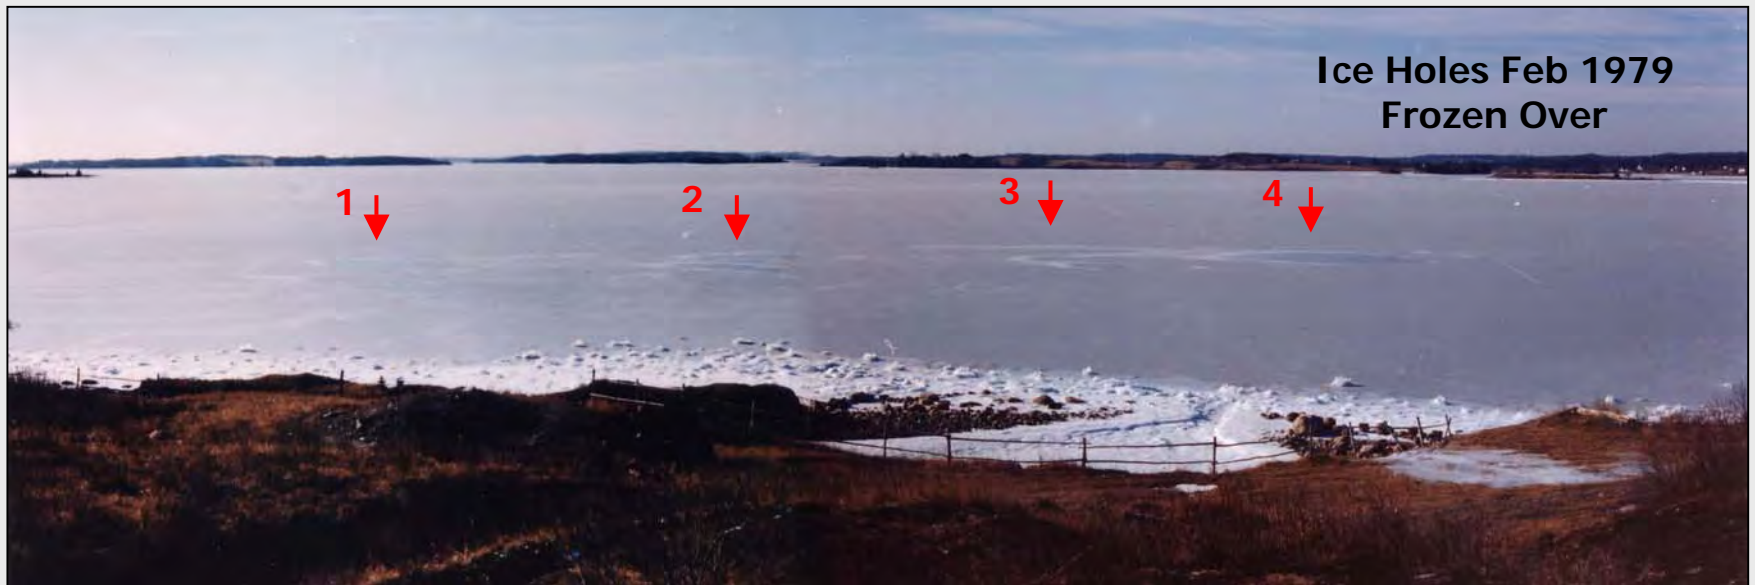
Ice Holes Occur Feb 1979 and Frozen Over

1. The ice holes result from cycles of drawdown and recovery of the water level in the area of 10X and the Money Pit.
2. This water level variation results in release of air bubbles from the bottom at the ice holes.
3. The water depth at the ice holes is about 20 to 25 feet.
